Case Study – 2

USING CRF for plastering – Cracks

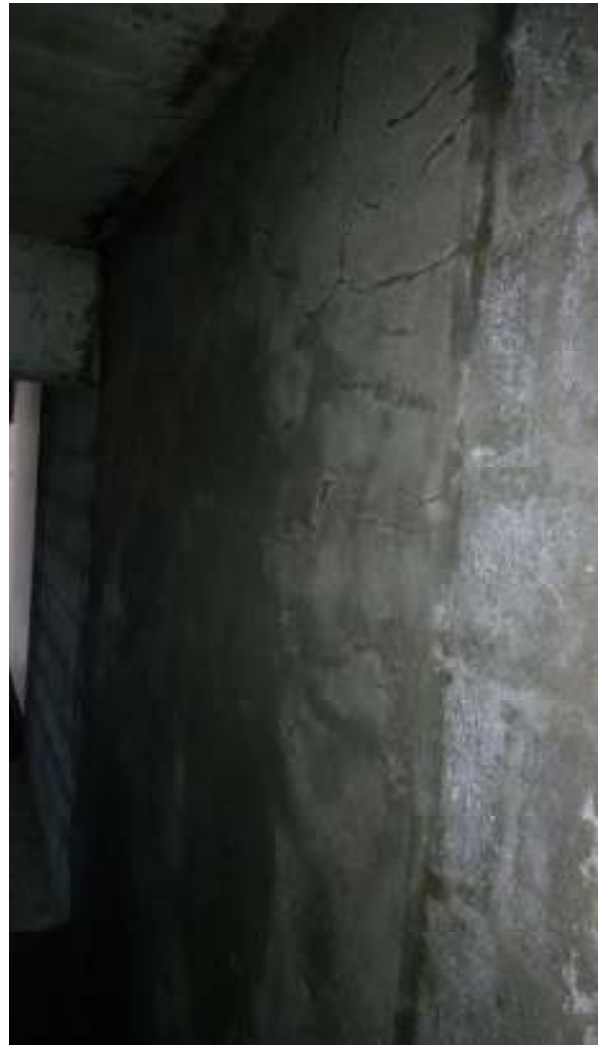
Problem: Internal walls plastered with CRF were having cracks in less than 5 days of curing. Few cracks appeared on the first day before curing started. While curing, above cracks extended and more cracks formed every day.

Cracks formed on the first day are due to plastic shrinkage and cracks formed later on are due to drying shrinkage.

Plastic shrinkage is aggravated by high water-cement ratio, high water content and high powder content. In this case, the CRF is very fine and has high water demand.

Wall done with CRF, cracked in less than 5 days

Addressing the problem: We requested the customer for a sample wall, for which he readily agreed. We changed nothing there, except for adding RenderCon '5S'. We have demonstrated the hydrophobicity the next day and waited for 20 days to check for any cracks.
