Case Study – 1

EFFLORESCENCE AND CRACKING THEREBY

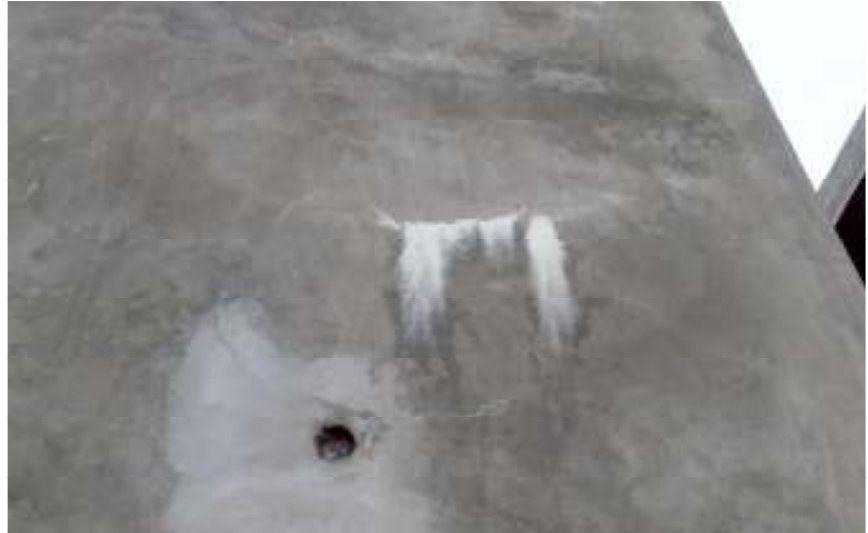
Problem: Efflorescence salts were coming up after Plastering – leading to ugly appearance of the wall plaster. When it rained, it further aggravated – depositing more efflorescence on the top.

Efflorescence as white deposit and cracking on the complete wall

What can happen further?: Efflorescence will lead to further cracking extending up to the putty and ultimately the plaster weakens up and gives away bonding with the brick wall – leading to plaster peeling off the wall.

Addressing the problem: Explained him about efflorescence and got his approval to complete a wall with RenderCon '5S'. We have requested him that we will use CRF in place of River Sand. He was apprehensive about the problems with CRF but agreed up on our insistence. Requested him to get a load of CRF available from the close by crusher to facilitate plastering with RenderCon '5S'.

We have used RenderCon '5S' in the preparation of mortar with CRF for plaster and completed a sample wall with his own masons. He was carefully observing the procedure, but said it was no different to what he was doing earlier. We left the site for the day and came back on the next day.

We demonstrated hydrophobicity on the walls by pouring water on the wall. He was happy for hydrophobicity but still not convinced about the cracking due to efflorescence, as it can come up after rain. We requested him to wait about for 10 days without curing. Fortunately, it rained on the 8th day and he could not find any efflorescence / cracking later.

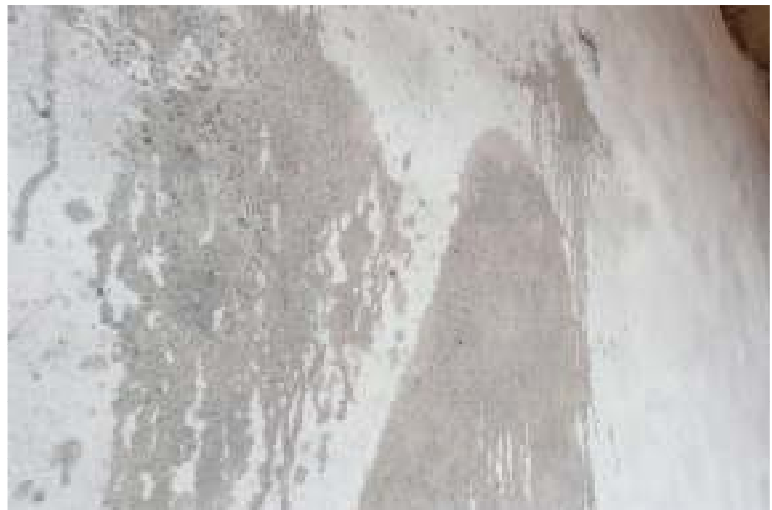
Plaster with RenderCon '5S' demonstrating hydrophobicity
