RENDERCON® ‘Super’ Tile Bedding Mortar

Case Study

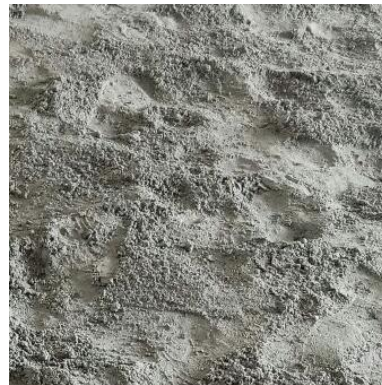
Dry Mixed (Cement + Sand)

- 2. Mixing Dry Mortar:** Many batches were prepared where each batch comprised of 2 bags of cement and proportionate sand for 1:4 mix ratio. 2 Powder pouches of RenderCon ‘Super’ sachets is emptied and mixed thoroughly in each batch.

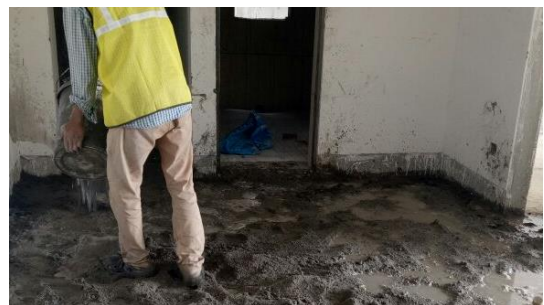
Wet Mixing (With Admixture)

- 3. Mixing Wet Mortar:** Along with the mix water, 2 liquid pouches of RenderCon ‘Super’ sachets is emptied is mixed in each batch. The mix water is then mixed thoroughly with the dry mix.

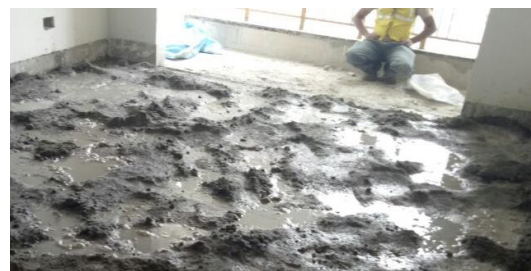
Mixing More Water, Ensuring no cement / Sand particle is dry.

- 4. Achieving Right consistency:** More water is obtained, poured over each batch to reach required consistency and see that all the mortar is wet. We repeatedly bothered the mason to use the spade to move the mortar upside-down continuously to ensure that no mortar is left dry without being wet. Just in case any dry mortar is found, we used more water to make it wet.

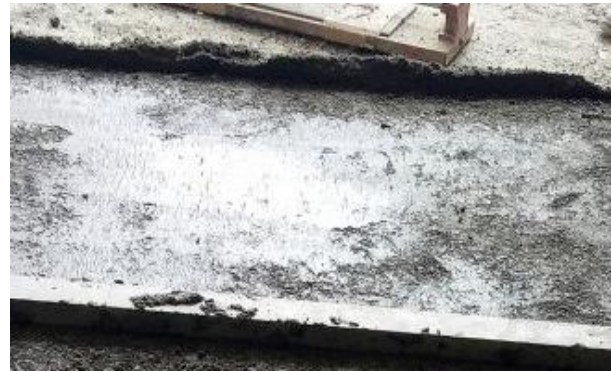
Water-sheen appearing on the surface

5. **Levelling and Water Sheen:** After ensuring that all the mortar is sufficiently wet, the levelling process started on the bed mortar. We get to see slight sparkling water-sheen if the mix has just enough water and such water-sheen ensures that no cement / sand particles are dry. The whole area is completely levelled.
