RENDERCON[®] '5S' Dampness Repair

PROBLEM TO ADDRESS

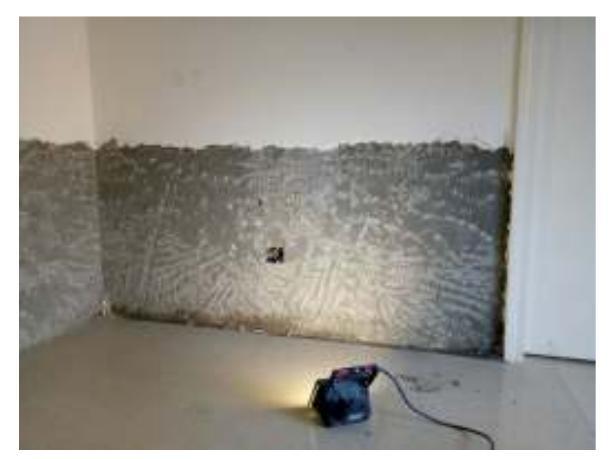
Chipped off and halogen lit

- 1. **Chipping:** All the putty and plaster removed and the surface was rough enough to receive the new plaster. However, dampness was observed on the rough surface. Halogen lamps were placed against this rough wall for about 4-6 hours.
- RenderCon '5S': Cement Mortar of 1:4 (Cement : M Sand) with 3 bags of cement and 3 sachets RenderCon 5S is prepared as 3 separate batches.
- Application: Masons applied mortar on the walls and levelled it to come to the level of the concrete wall, with due allowance to putty to come up over it.
- 4. **Halogens:** After about 12-15 hours of application of mortar, halogens were once again switched on to dry out any moisture that must have crept in before the mortar is set. The halogens were on for about 5-6 hours.

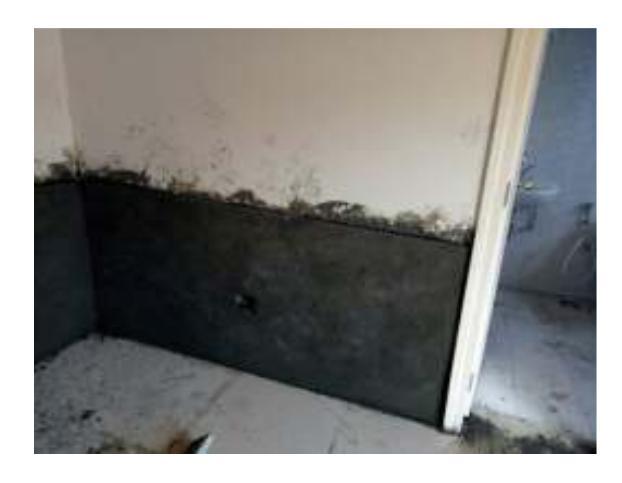
Plaster applied and ready for taking halogen light (after setting).

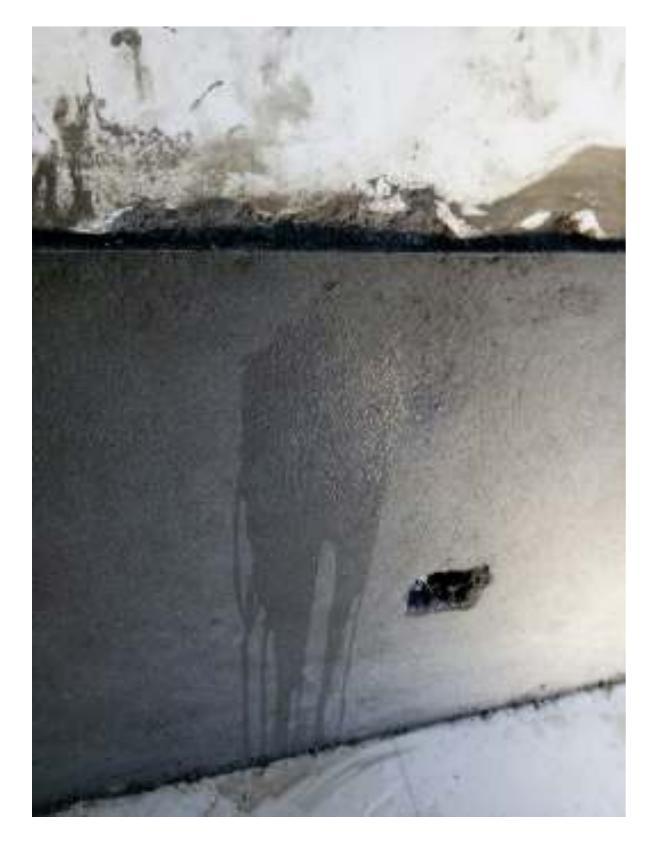
Tested for Hydrophobicity after 48 hours.

- 6. **Check:** Monsoon set in the following week, where there were no signs of dampness on the plastered wall.
- 7. **Putty:** After 15-20 days of monsoon, putty was applied after ensuring that no dampness is observed.
