Case Study – 3

USING Sand - addressing mapping / crazing Cracks

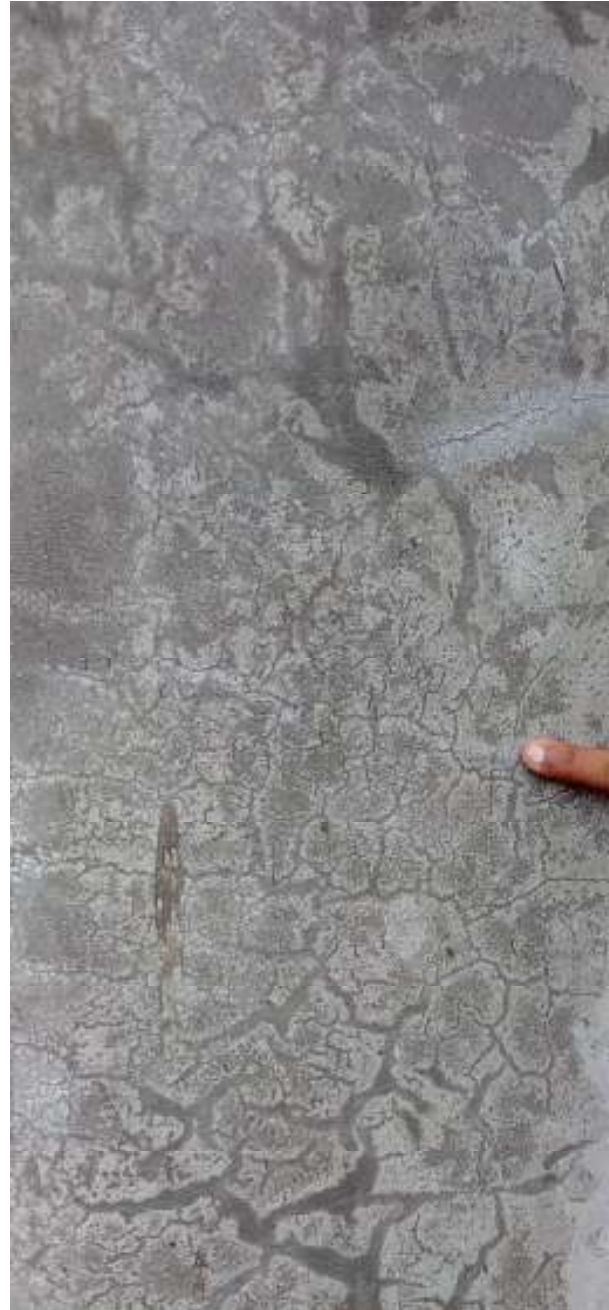
Problem: Walls plastered with River Sand are forming cracks. Closely spaced cracks are called crazing, while widely spaced are called map-crazing (mapping).

Presence of clay in sand is detrimental to plaster. Clay present in plaster expands and contract with water. Map crazing is usually formed on the first coat of the plaster where the sand is having clay. Crazing happens due to presence of clay and rich mix contributing to plastic shrinkage from high powder content and water, this usually happens on the second coat. During the first few days, crazing and map-crazing are not visible until the wall is washed with water.

Map crazing is initiated on the first day of plaster while setting due to loss of water and clay travelling to the surface. Map crazing is propagated with drying shrinkage due to curing operations. Crazing can be avoided by avoiding rich mixes as second coat. However, if the first layer had map crazing, it usually forms map crazing / crazing on the next surface as well.

Wall Crazed / Map-Crazed

Addressing the problem: We requested the customer to bring CRF at much cheaper price than sand and apply it with RenderCon '5S'. The surface finish improved with the CRF and the wall was looking better.
